6^{as} Jornadas Portuguesas de Engenharia de Estruturas
Encontro Nacional de Betão Estrutural 2022
12^o Congresso Nacional de Sismologia e Engenharia Sísmica

TAGUS RIVER BRIDGE STRINGER BEARING REPLACEMENT AND STRUCTURAL STRENGTHENING

Tom Spoth, PE - PARSONS

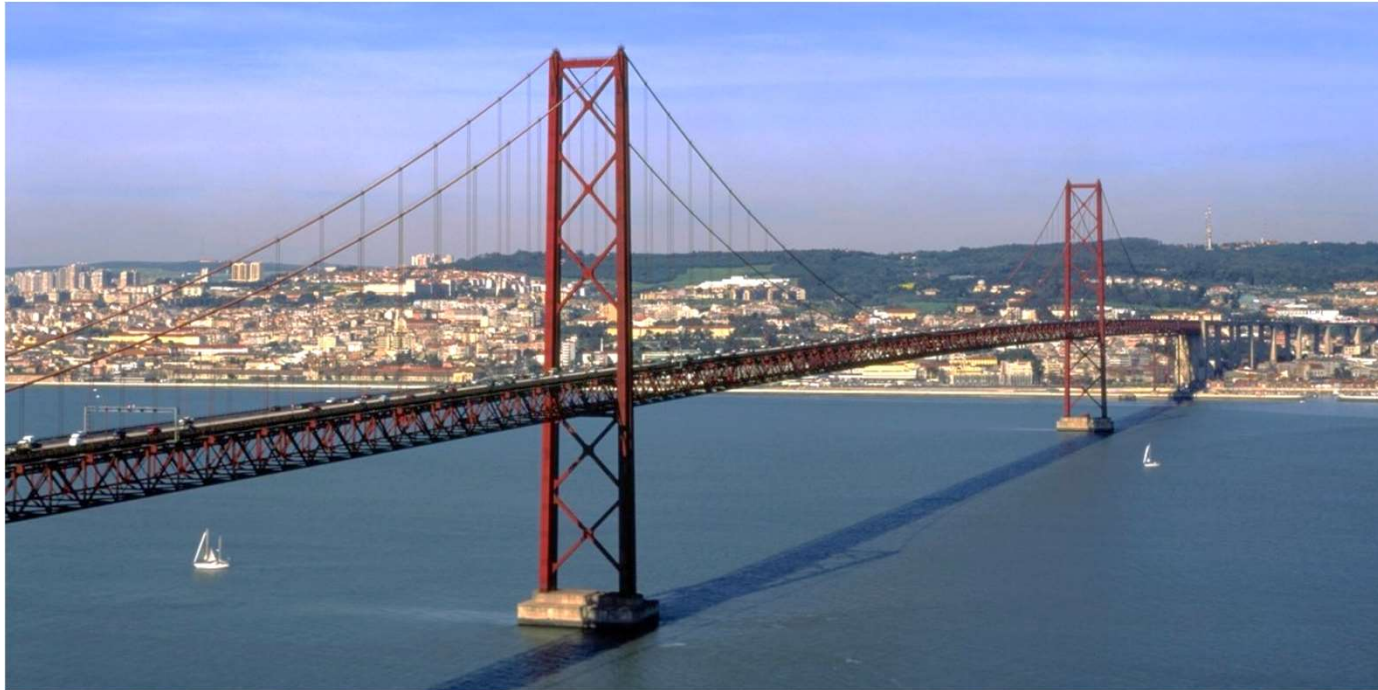
Original Construction

- Year Built:
 - 1966 by American Bridge Division of U.S. Steel Corporation based. on Design Engineer: Steinman, Boynton Gronquist and London.
- Notables:
 - Main span: 1,013m
 - Second longest span designed for rail loading
 - Total length between anchorages: 2,278m
 - World's longest continuous truss
 - World's deepest bridge foundation: South Tower caisson 83m below water level

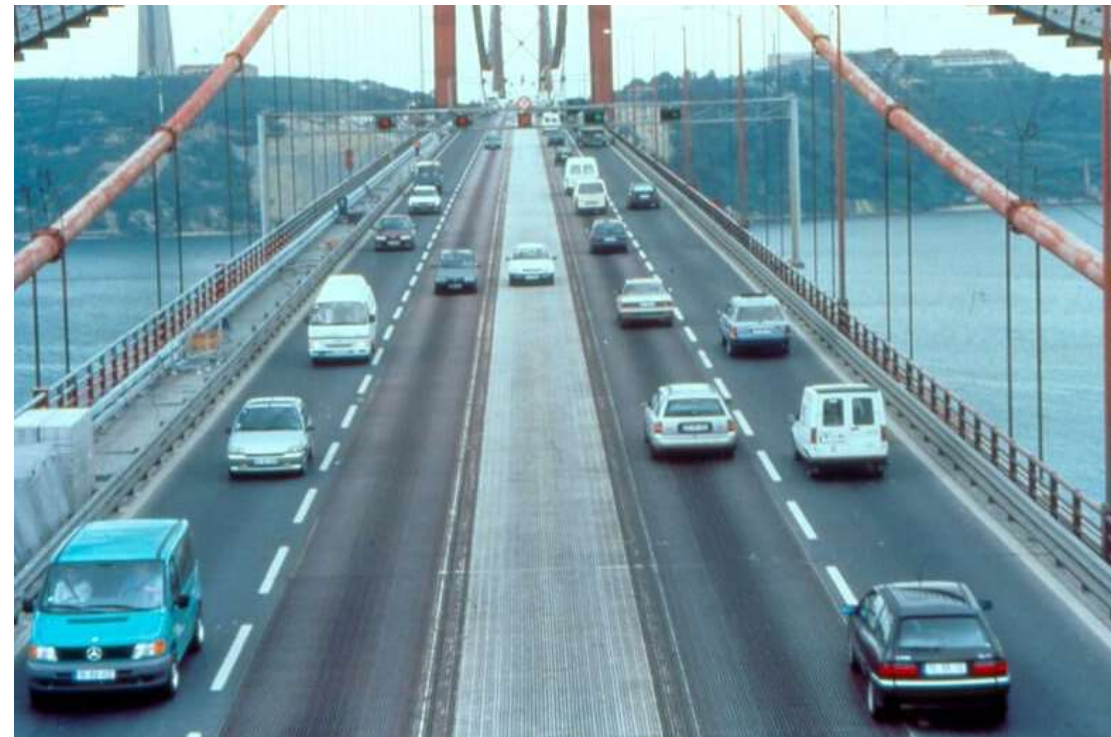
1990-1998 Cross section with Modified Roadway

4 Lanes + 1 Central Bi-Directional Lane

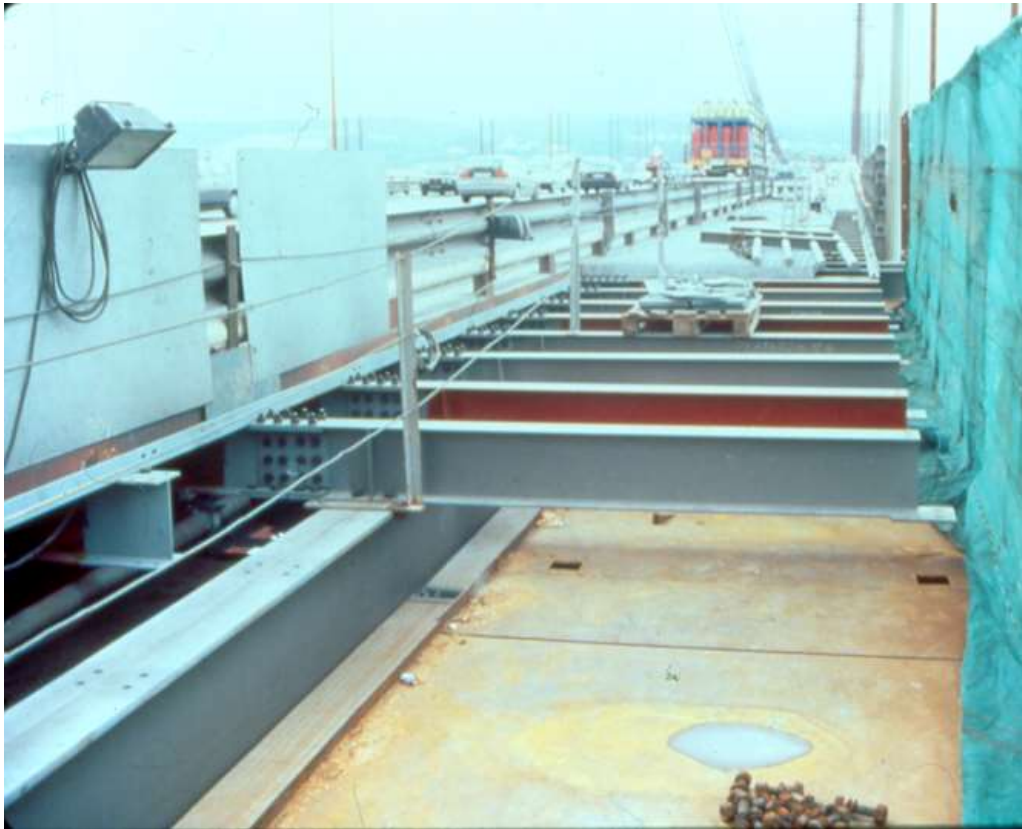
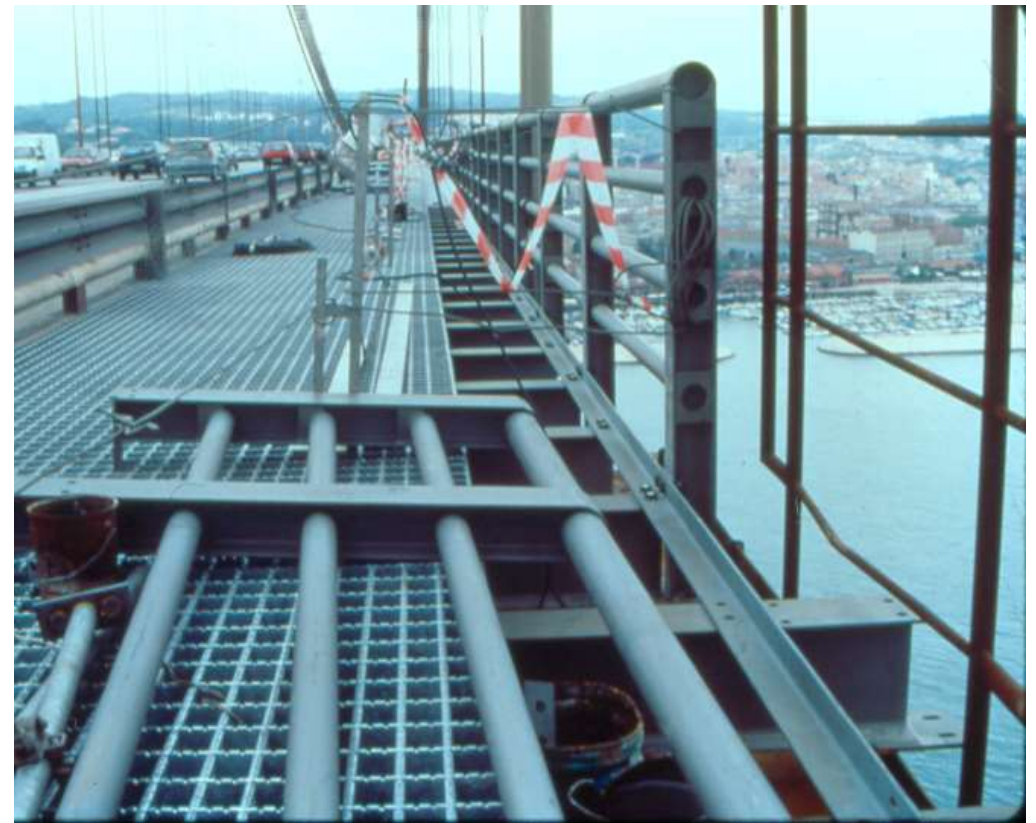
Expansion to 6 lanes

- Expand upper deck from 5 lanes to 6
- Convert lower level to two-lines of rail
- Add secondary suspension system including new anchorages

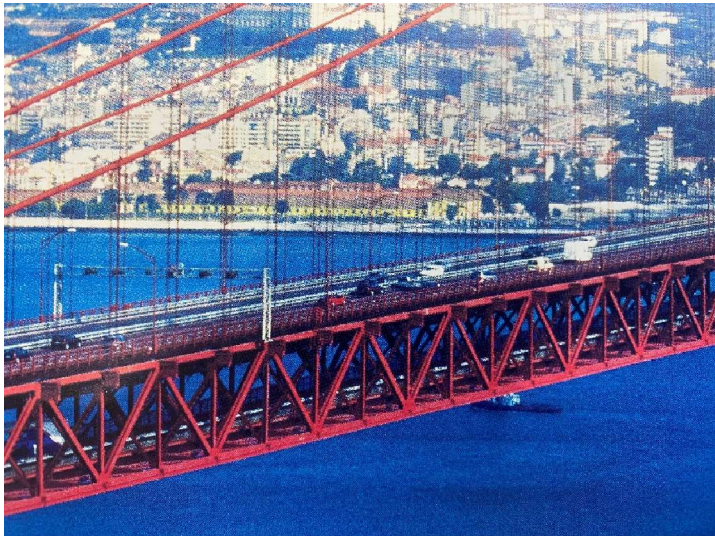
Global and Local Element Structural System

- Classic truss-stiffened suspension bridge
- Stringer-crossbeam deck framing
- Relief joints at even numbered panel points
- Stringer bearings on floor trusses at relief joints

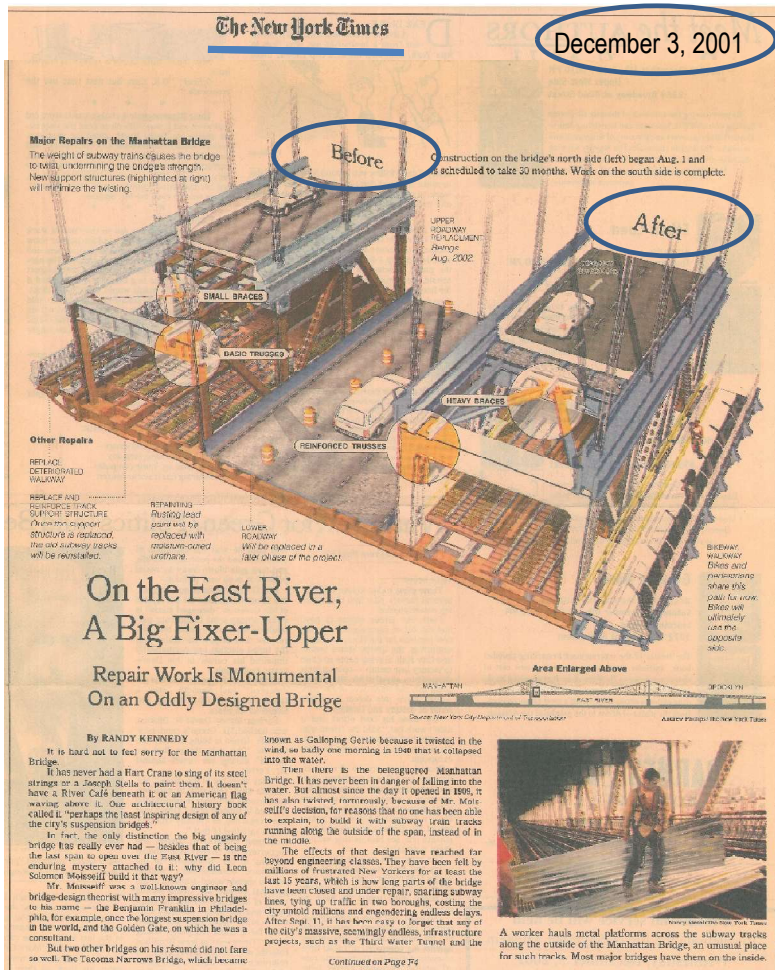
The Overall Retrofit Scheme

New Stringer Bearings

Heavy Bracing

Reinforced Truss
